National Transportation Safety Board
Washington, D.C. 20594

Safety Recommendation

Date: July 13, 1999

In reply refer to: A-99-51 through -54

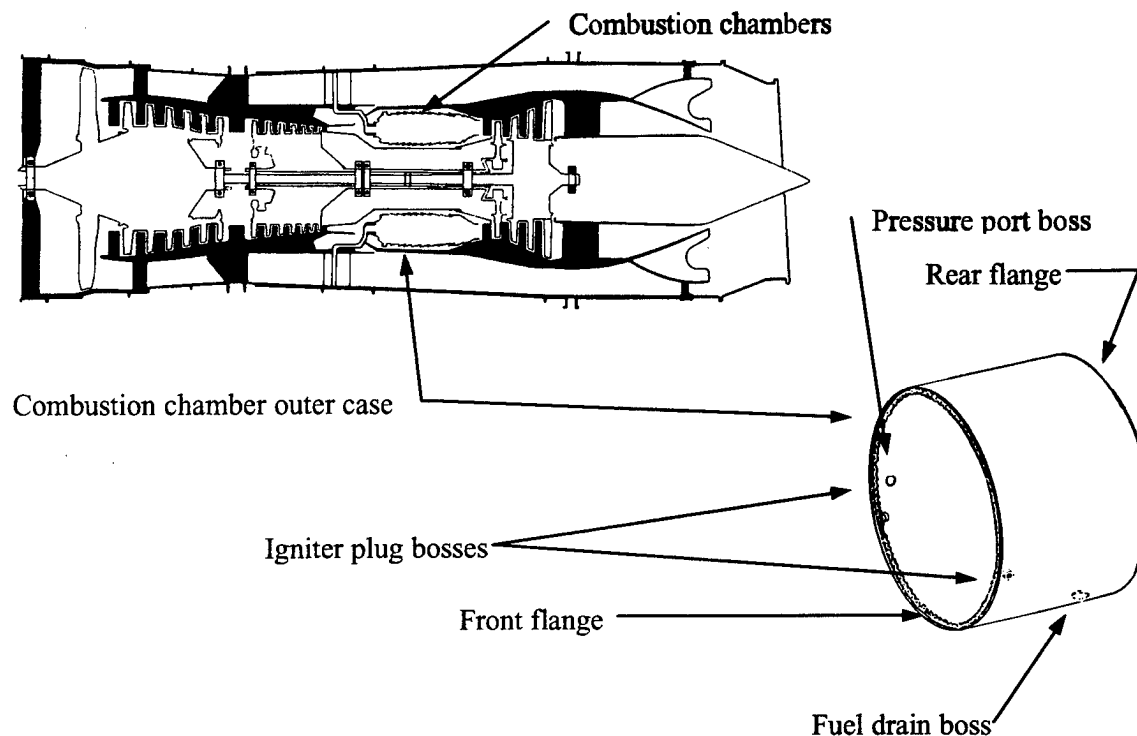
The CCOC is a barrel-shaped structure that houses the combustion chambers and contains four circular-shaped bosses, mounted on which are two igniter plugs, a pressure port, and a fuel drain (see figure 1). The ruptured CCOC was assembled in six pieces: the front flange³ and body, the four bosses, and the rear flange. The front flange and body of the case and the four bosses were made of AMS [Aerospace Material Specification] 5613 410 stainless steel,⁴ and all of the

Figure 1. JT8D-200 engine cross section showing the location of the CCOC, and an enlarged view of the CCOC showing the location of the bosses and the case's front and rear flanges.

The ruptured CCOC was examined at the National Transportation Safety Board's materials laboratory. This examination revealed a fatigue fracture that had multiple origins along the weld on the exterior side of the fuel drain boss. The fracture had propagated about 150° around the boss and then axially, about 1½ inches forward and ½ inch rearward. The fatigue striations indicated that the crack had existed for approximately 1,340 cycles before the CCOC ruptured. The fracture originated from a mechanically thinned area of the boss' flange that had grinding marks consistent with previous work. The measured thickness of the boss flange adjacent to the fatigue fracture was 0.080 inch; however, the fuel drain boss' engineering drawing required a thickness of 0.099 to 0.109 inch.
